The East River Esplanade

Located on the East River between East 62nd Street and East 125th Street
In the borough of Manhattan

Town Hall Meeting
September 19, 2017

Erik Linsalata, PE, Gabrielle Czernik, PE
Parks Capital Design

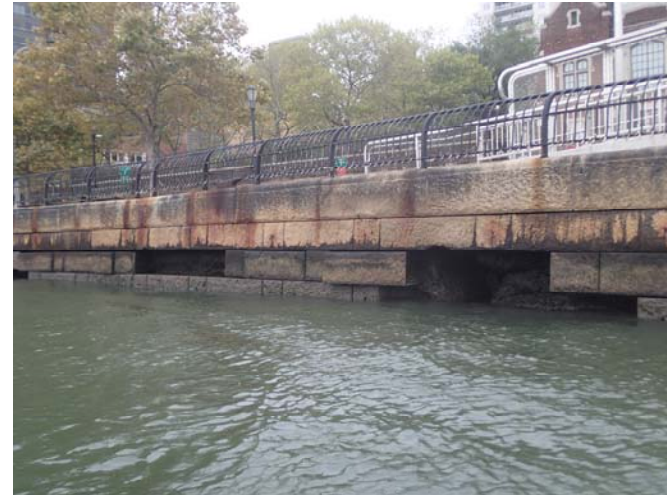
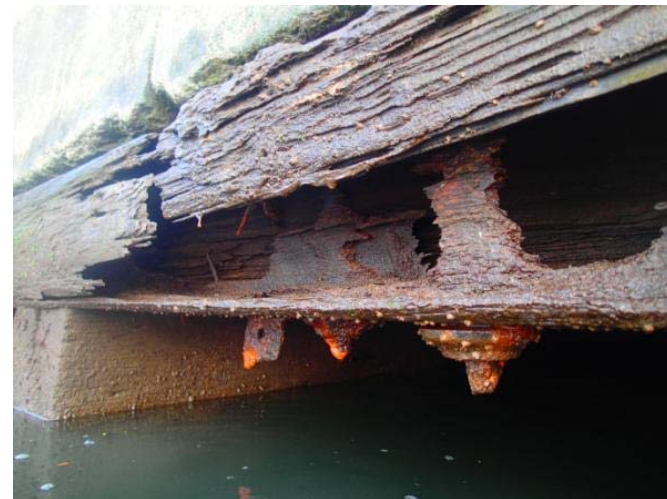
- Over 10,000 linear feet inspected
- Characteristic grout loss along granite fascia block joints
- Loose/displaced/missing fascia blocks in various locations
- Exposed concrete seawall surfaces exhibit cracking, spalling and/or erosion

- Over 11,000 linear feet inspected
- Overall moderate marine borer activity observed
- Minor to severe timber deterioration

1. Repair of individual elements of structures (ER)
(e.g., repair of individual piles)
2. Partial reconstruction of platform structures (PR)
(i.e., partial demolition of existing platform structure and construction of new portions)
3. Complete reconstruction (CR)
(i.e., complete demolition of existing structure and rebuilding a new platform replacement)

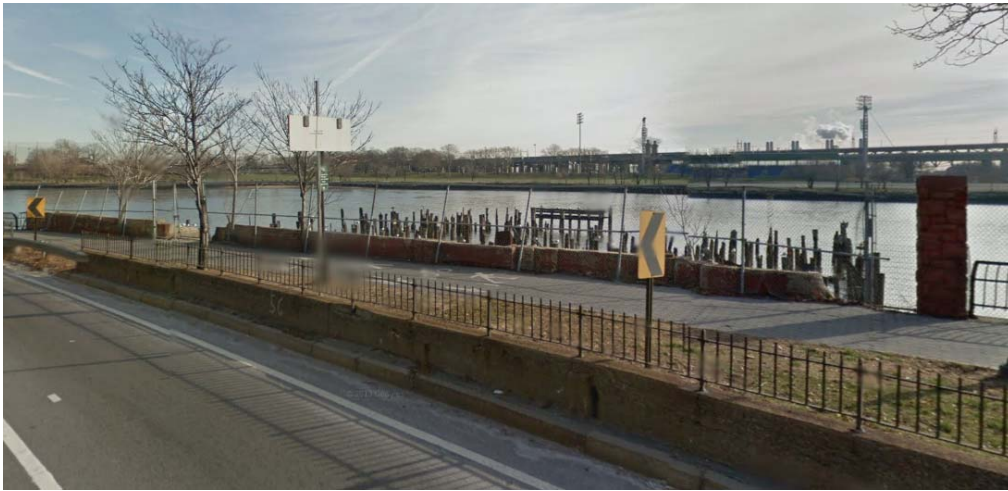
View from FDR Drive Northbound, pre-collapse

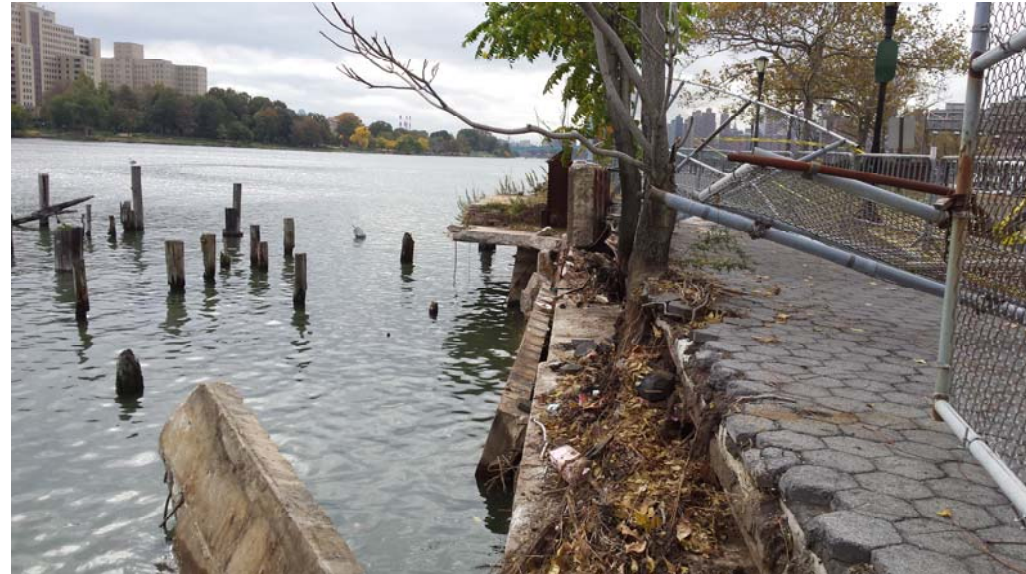
- Partial collapse of concrete pier remains, October 2016
- Some damage to bulkhead and esplanade
- Former factory site, only pier remnants and abandoned utilities remain (DCAS jurisdiction)

Partial collapse and loss of bulkhead

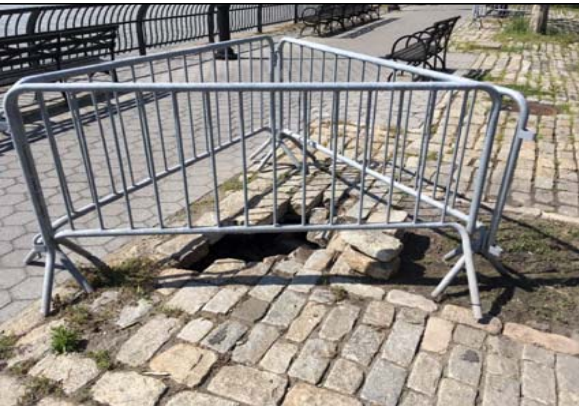
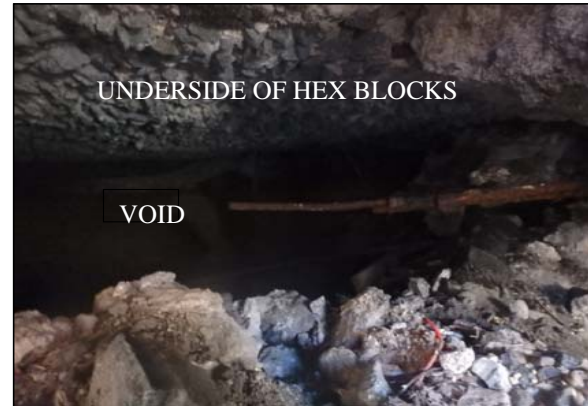
E 115th St. Low-Level Relieving Platform

Overall Rating: **CRITICAL**
 Timber piles = **POOR**
 Timber pile cap = **POOR**
 Timber line cap = **POOR**
 Granite fascia panels = **FAIR**
 Concrete seawall = **POOR**
 Hexblock pavers = **POOR**

- Three locations at topside exhibit voids
- Timber line cap in moderate to severe condition
- Timber pile caps in advanced to severe condition
- Moderate to severe pile deterioration on all observed piles
- Critical sections now fenced off from public use
