The East River Esplanade

Located on the East River between East 62nd Street and East 125th Street
In the borough of Manhattan

Town Hall Meeting
September 19, 2017

Erik Linsalata, PE, Gabrielle Czernik, PE
Parks Capital Design

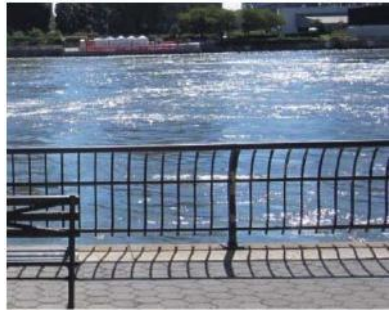
Refurbished Sea Rail
