The East River Esplanade

Located on the East River between East 62nd Street and East 125th Street
In the borough of Manhattan

Town Hall Meeting
September 19, 2017

Erik Linsalata, PE, Gabrielle Czernik, PE
Parks Capital Design

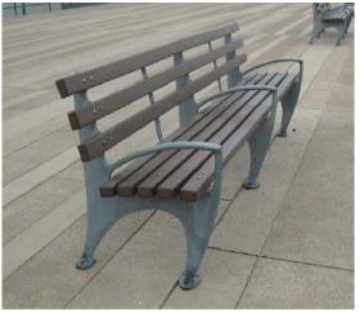
1964 World's Fair Bench

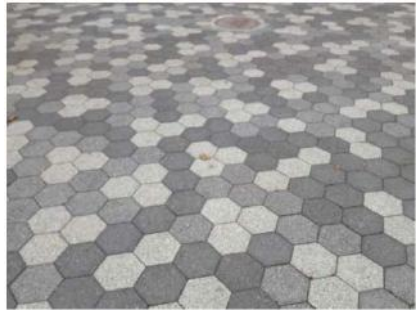
Asphalt Hex Block
